Influence Of Impact Damage On Carbon-Epoxy Stiffener Crippling

Dawn Jegley

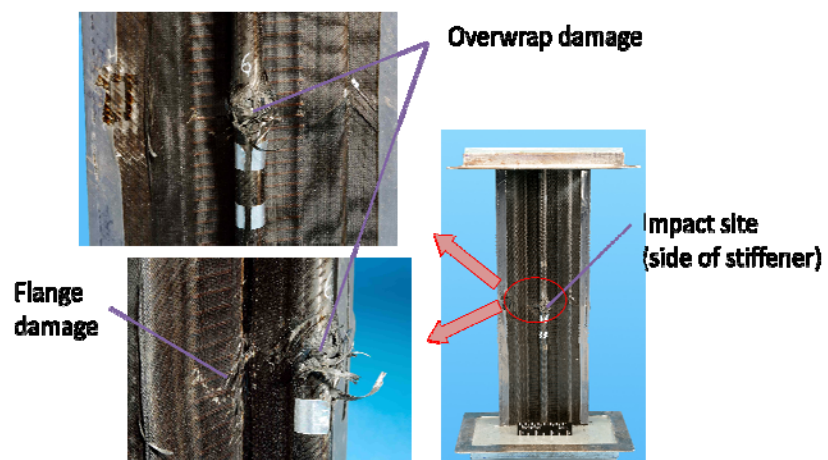
Figure 35. Failed specimen with side impact and no fatigue.

A comparison between failure loads obtained in the present study and those obtained in studies of nominally identical specimens with no impact damage are shown in figure 15 and Table III. Photographs of failed pristine and impacted specimens are shown in figure 32-35. These results indicate that fatigue cycling has no effect on failure loads and non-visible impact damage has only minimal influence on failure load or mode. In addition, fatigue cycling in the presence of impact damage did not influence the failure load any more than impact alone, implying there is no damage growth through the fatigue cycles.

Rod-stiffened specimens failed midlength across the full width of the specimen. Minimal delamination can be seen between the flange and skin. Overwrap damage can be seen around the rod. Specimens R3 and R4 failed in the same manner [2].
